DRUG ALERT

CLASS 4 MEDICINES DEFECT INFORMATION

<u>Inhixa solution for injection in pre-filled syringe 2,000 IU (20 mg) in 0.2 mL; 4,000 IU (40 mg) in 0.4 mL; 6,000 IU (60 mg) in 0.6 mL; 8,000 IU (80 mg) in 0.8 mL; 10,000 IU (100 mg) in 1.0 mL</u>	<u>EU/1/16/1132/012</u>
	<u>EU/1/16/1132/014</u>
	<u>EU/1/16/1132/016</u>
	<u>EU/1/16/1132/018</u>
<u>(Enoxaparin Sodium)</u>	<u>EU/1/16/1132/020</u>

▼ Inhixa (enoxaparin sodium) solution for injection: rare cases of self-activation of safety device in unopened, unused pre-filled syringes.

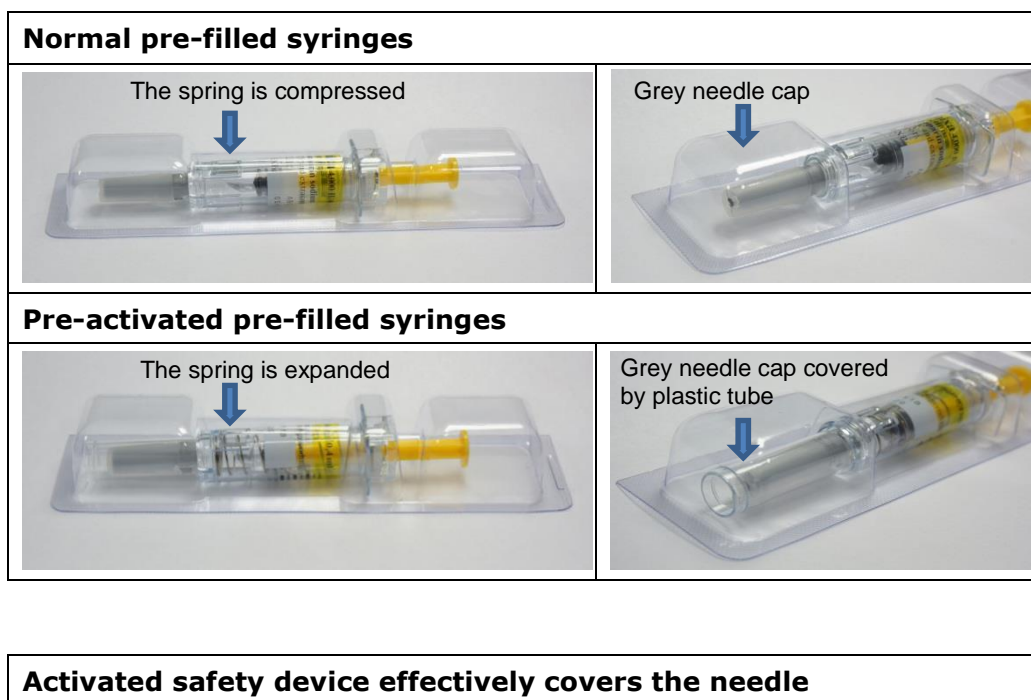
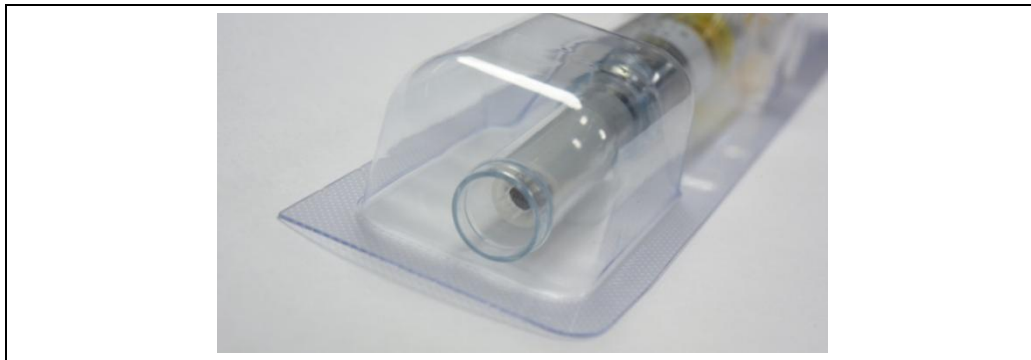
Figure 1. Pre-activation is easily detectable:

- In very rare cases, premature self-activation of the safety device has been observed in unused, unopened pre-filled Inhixa syringes (see Figure 1 below); when premature activation has occurred, medicine administration is not possible.
- **Pharmacists should visually check all devices before dispensing Inhixa and make sure they have sufficient stock of Inhixa available as replacements.**
- There is negligible risk of needle stick injury when handling these pre-filled syringes, since the safety device ensures full coverage of the needle; the risk of a patient missing a dose can be minimised by the above checks and advice to patients.

Self-activation of the safety device has been observed rarely in unused, unopened blisters containing Inhixa pre-filled syringes. An analysis has shown that the incidence of self-activation is 0.001%. To date, the issue has not been associated with any adverse event or risk to public health.

The possibility of needle stick injury is negligible as the safety device ensures full coverage of the needle. With regard to the potential risk of missing a dose, this is easily manageable: as the product is presented in transparent blisters, self-activation is visually apparent and easily detectable before dispensing and use. Moreover it is not necessary for pharmacists to open the blister packs to perform a visual check of syringes blisters before dispensing.

- Pharmacists should visually check all Inhixa syringes before dispensing to check if they are affected by the self-activation defect as shown in the DHCP diagrams. Do not open the syringe blisters.
- Individual syringes that are affected by the self-activation defect should not be dispensed to patients.

Detailed investigation by the manufacturer has pinpointed the root cause, corrective and preventive actions have been implemented to prevent recurrence of the issue.
